The Walkability Indicator

A Case Study of Boulder City, Colorado, USA

- Tsuyoshi Kaburagi, Daryoosh Ardalan
 - January 23, 2013
 - University of Colorado Denver

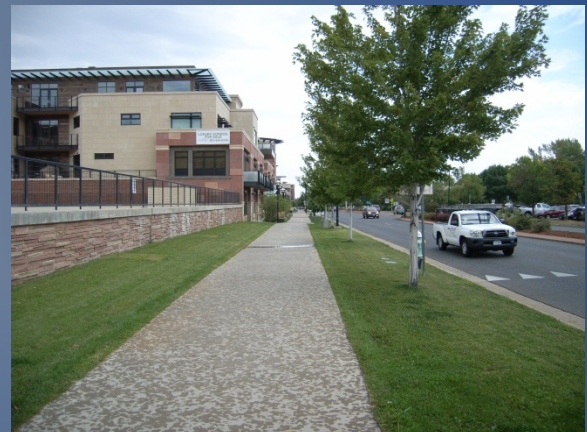
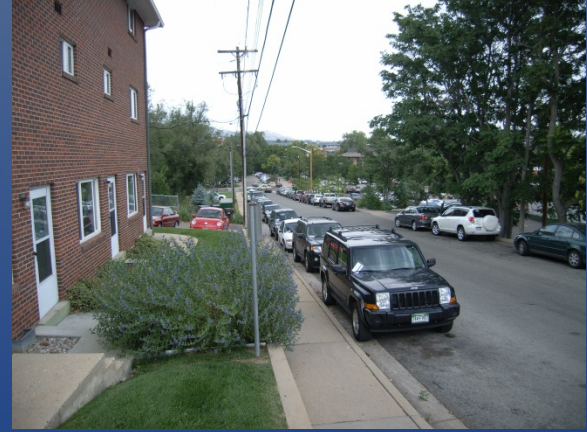
Medium

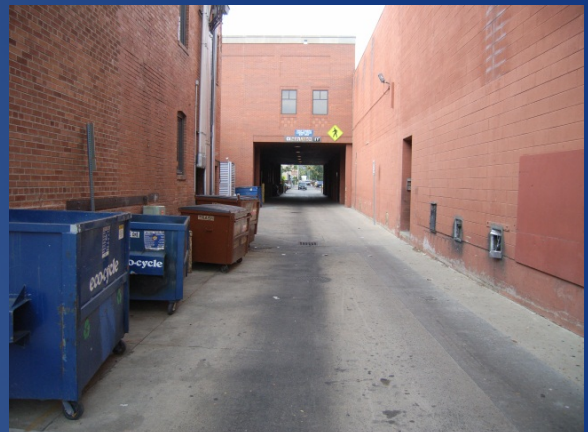
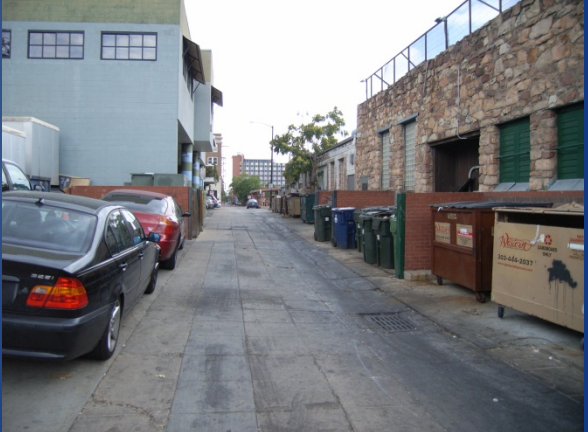
Low

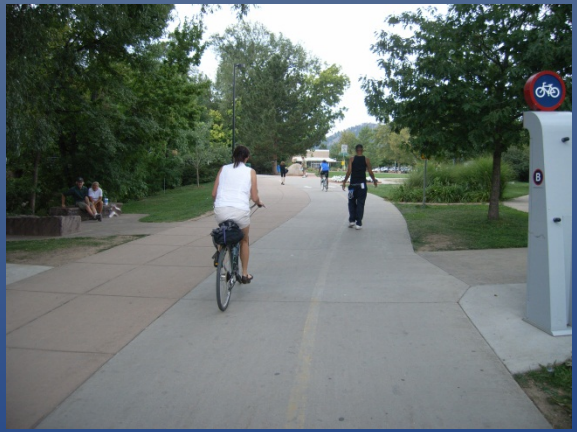
High

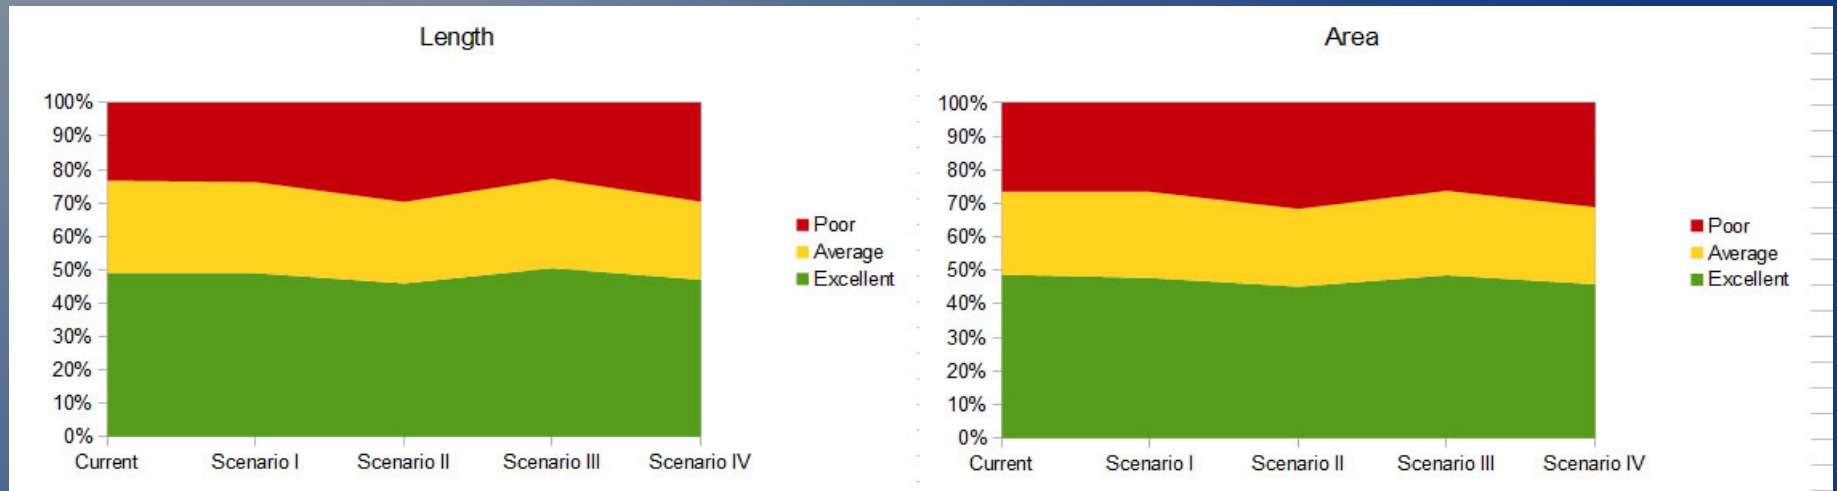
9) Findings (comparison of length & areas)

Length percentage

Area percentage

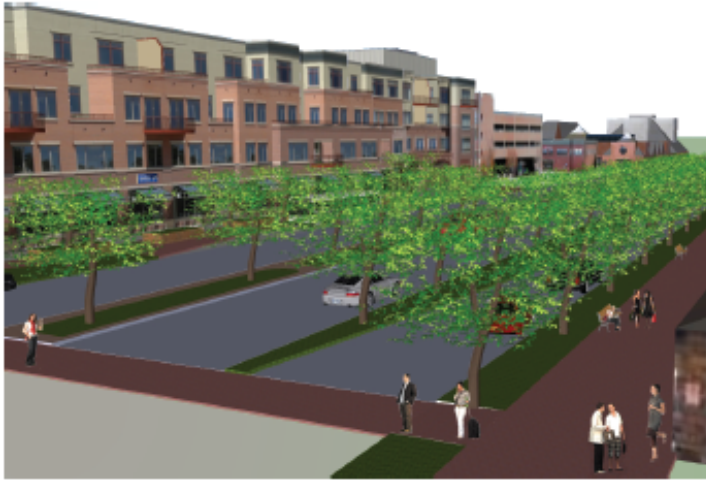
Birds Eye View: Looking NE

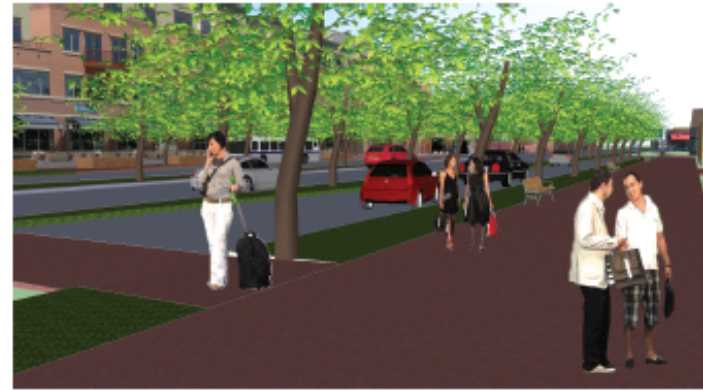
User's Point of View: SW Corner of 13th and Canyon
